[Docket No. FAA-2007-0218; Directorate Identifier 92-ANE-56-AD; Amendment 39-16894; AD 2011-26-04]

Airworthiness Directives; Lycoming Engines, Fuel Injected Reciprocating Engines

DATE: June 4, 2010 Service Bulletin No. 342F
(Supersedes Service Bulletin No. 342E)
Engineering Aspects are
FAA Approved

SUBJECT: Fuel Line (Stainless Steel Tube Assy.) and Support Clamp Inspection and Installation

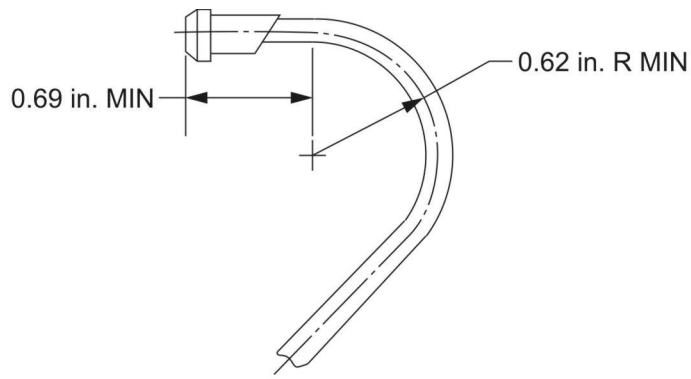
Figure 1. Fuel Line Showing Minimum Dimension for Bending

- Dents
 - Pits
 - Nicks
 - Stains caused by fuel leakage
2. Remove any line that appears faulty. Do not attempt to repair any line that leaks. Bent lines may be straightened; however, any line with an inside radius less than 5/8 inch must be replaced. Do not reuse any line that is dented; cracks can develop at the site of a dent. Also inspect solder joints at ends of lines for cracks. Replace cracked lines, they cannot be repaired. See the latest revision of Service Instruction No. 1301 for superseded fuel line identification, bending requirements and replacement information.
